# Investigating the Impact of Mounting Clamps and Frame Adhesive Joints on Glass Breakage of PV-Modules

<sup>1</sup>Fraunhofer Institute for Solar Energy Systems ISE, <sup>2</sup>RWE Renewables GmbH, Deutschland

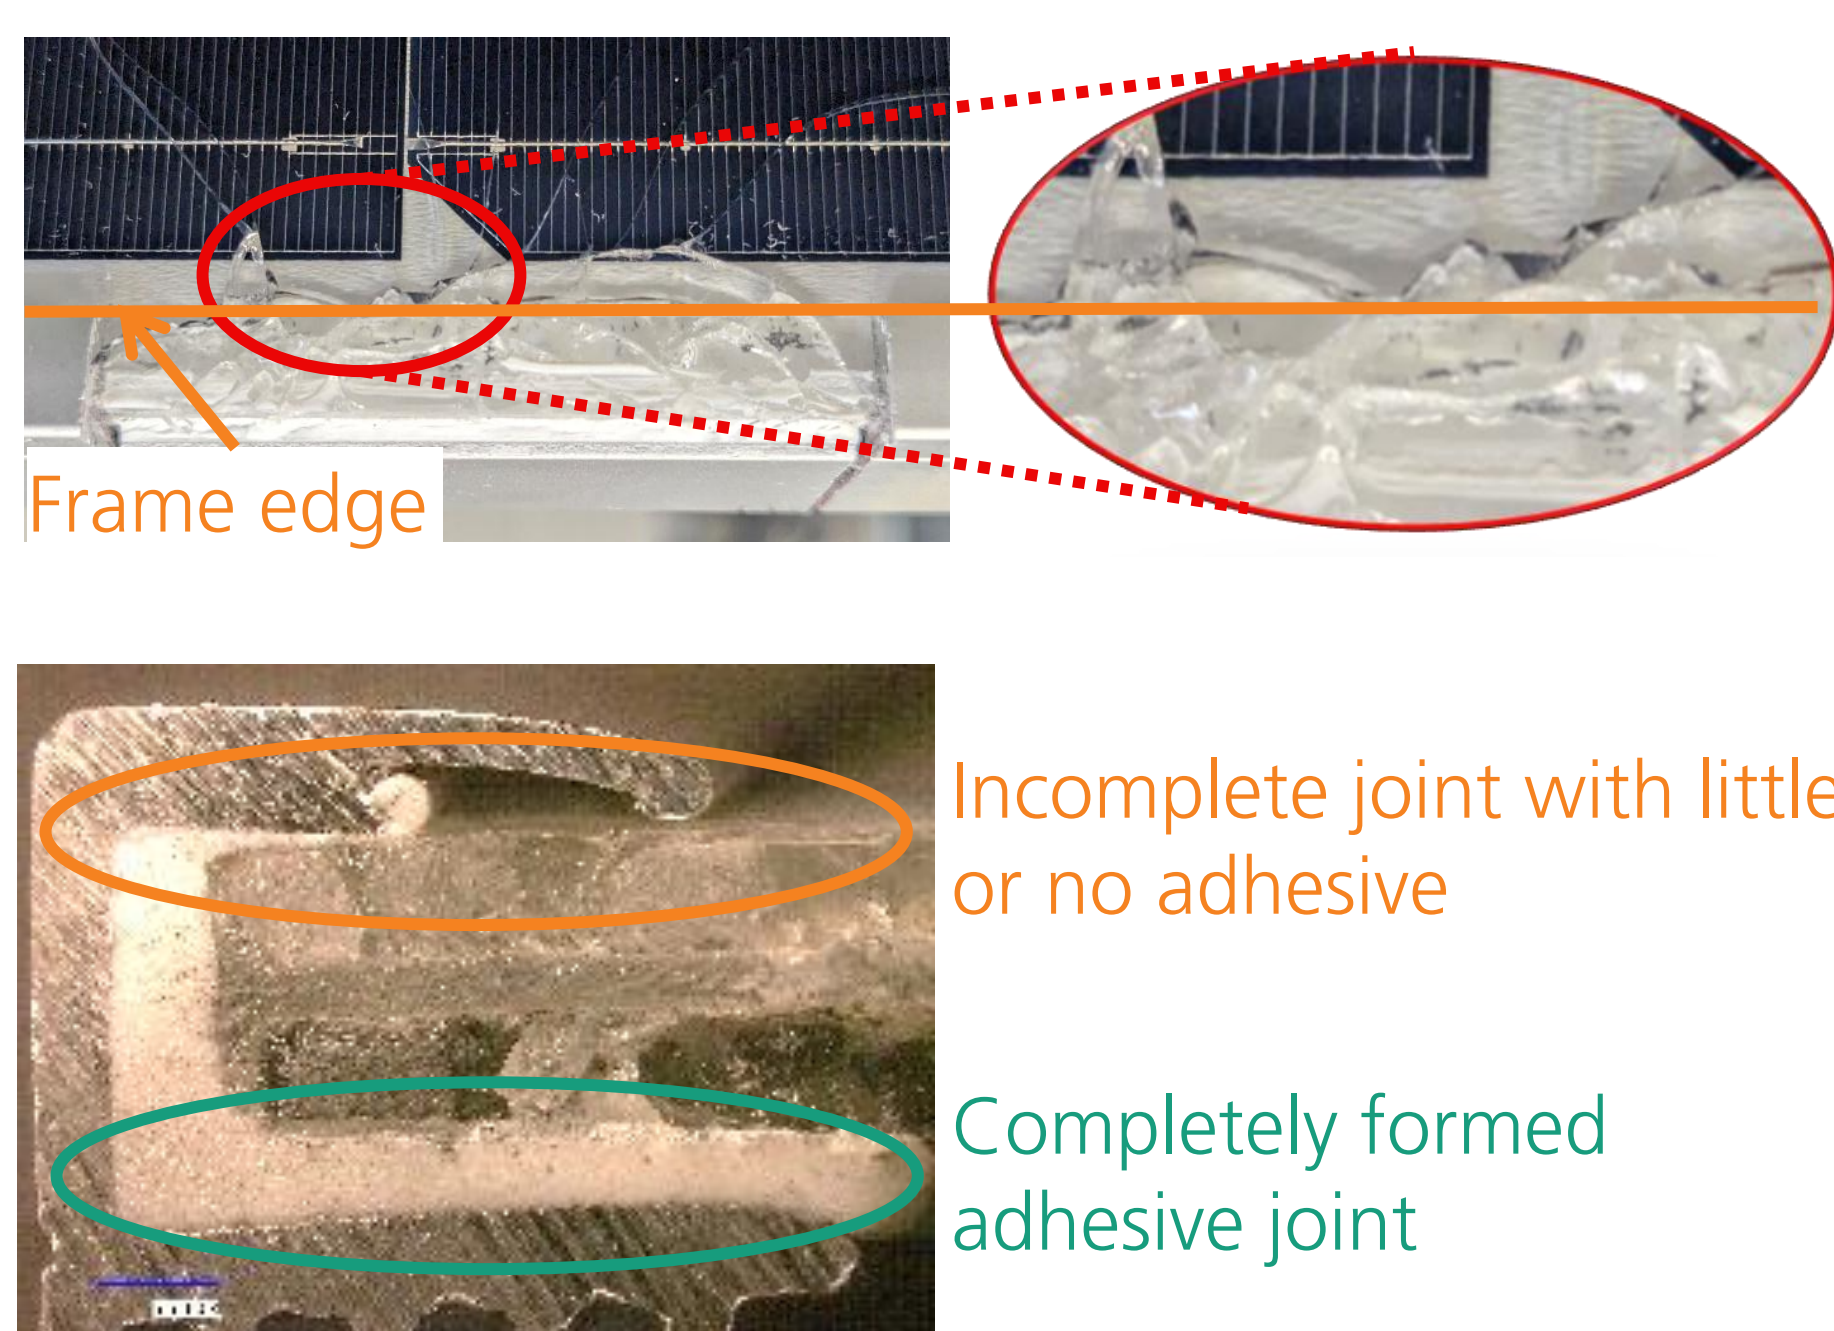
- Fracture pattern analysis:  
Fracture origin in front glass at interface between frame edge and glass in the clamping area (Fig. 2, top)
  - Cross-section analysis:  
Incomplete adhesive joint on the top of the laminate is found often (Fig. 2, bottom), resulting in direct metal to glass contact at interface frame edge to glass
- **Origin of glass fracture is at the interface between frame edge and glass, where often an incomplete adhesive joint can be seen**

Fig. 2: Fracture pattern analysis (top) and cross-sectional image of incompletely formed adhesive joint

- Origin of fracture is in the clamping area
- Higher tensile stress in regions with incomplete adhesive joint
- **Process control of adhesive application needs to be carefully monitored**
- Clamps with a grounding groove cause higher frame deformations at the clamping position due to the lever arm resulting in higher tensile stresses in comparison to clamps without a grounding groove

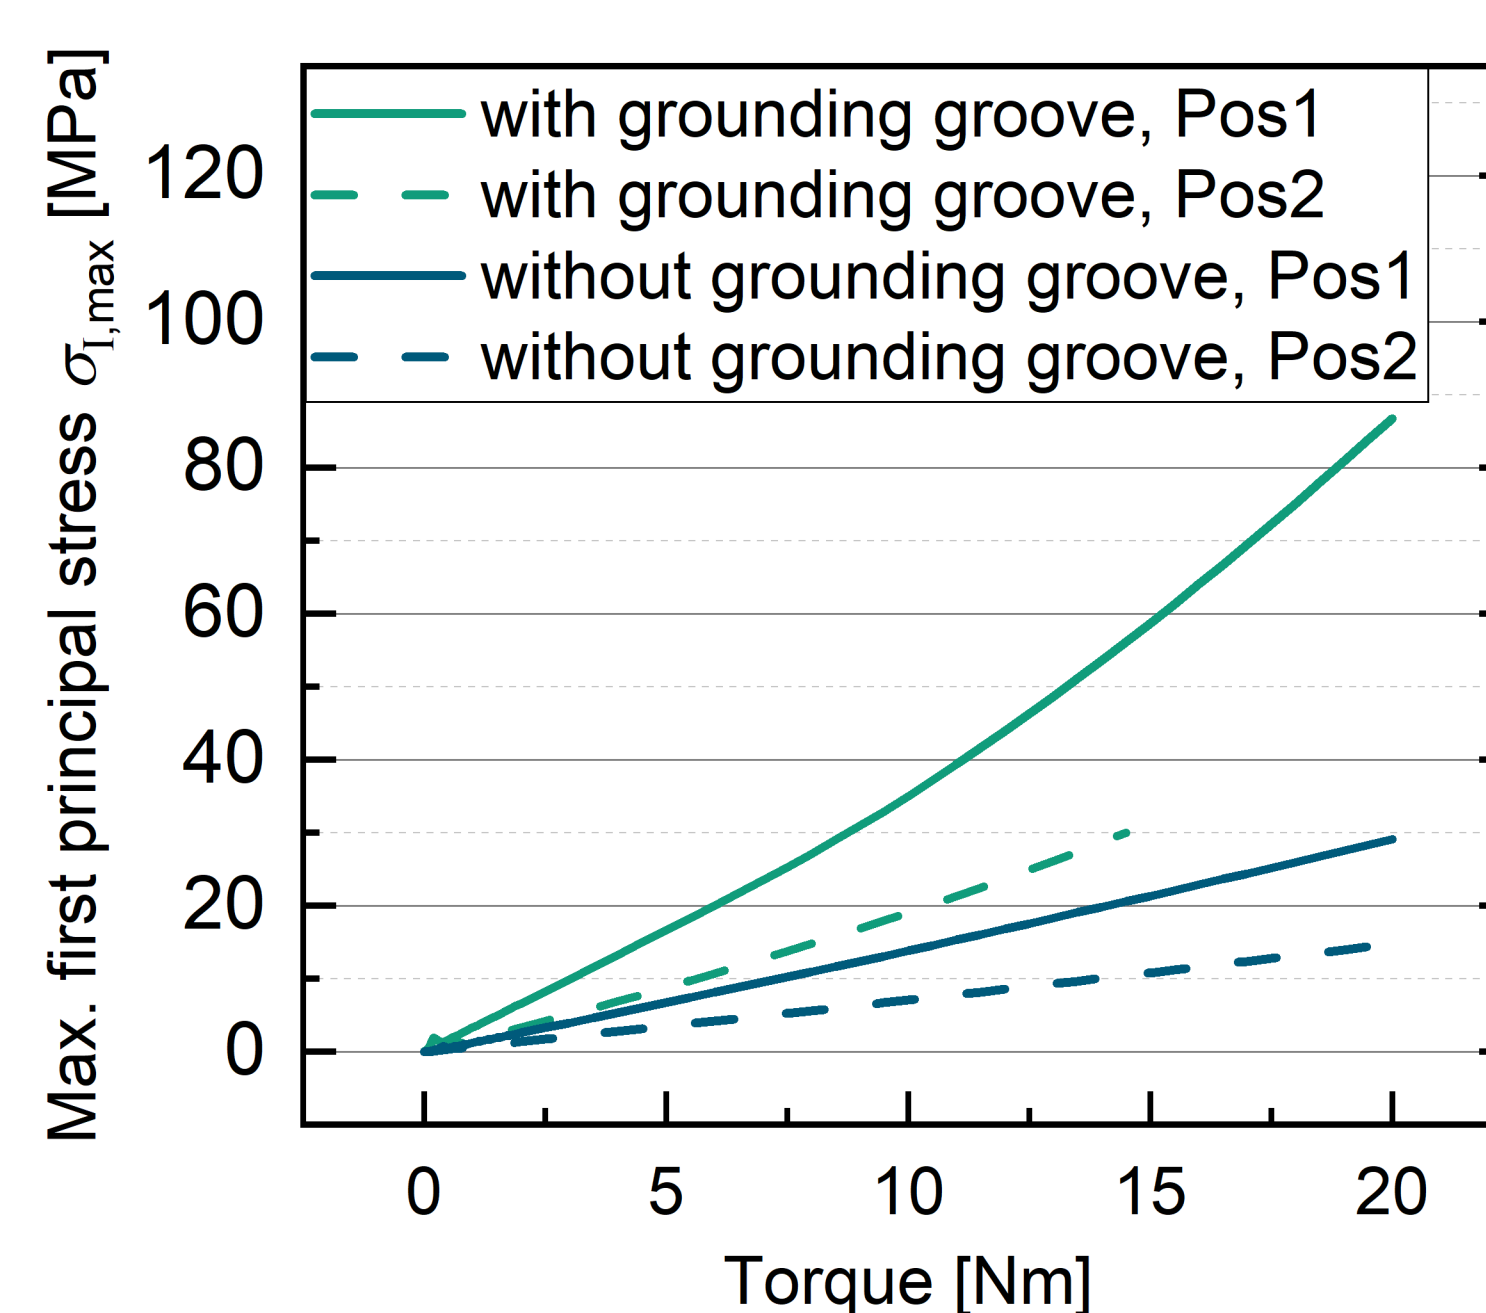
- Frame adhesive acts as a deformation buffer between frame and glass
- When tightening the clamps an incomplete adhesive joint (Fig. 3, Pos 1) results in a higher local deformation of the glass compared to an ideal joint (Fig. 3, Pos 2)
- A higher local deformation results in a higher first principal stress → Module is more prone to glass breakage
- **Incomplete adhesive joints result in a higher first principal stress in the glass**

Fig. 3: First principal stress in the front glass for an incomplete adhesive joint (solid) and a complete one (dashed) using a frame clamp with a grounding groove (green) and without one (blue)

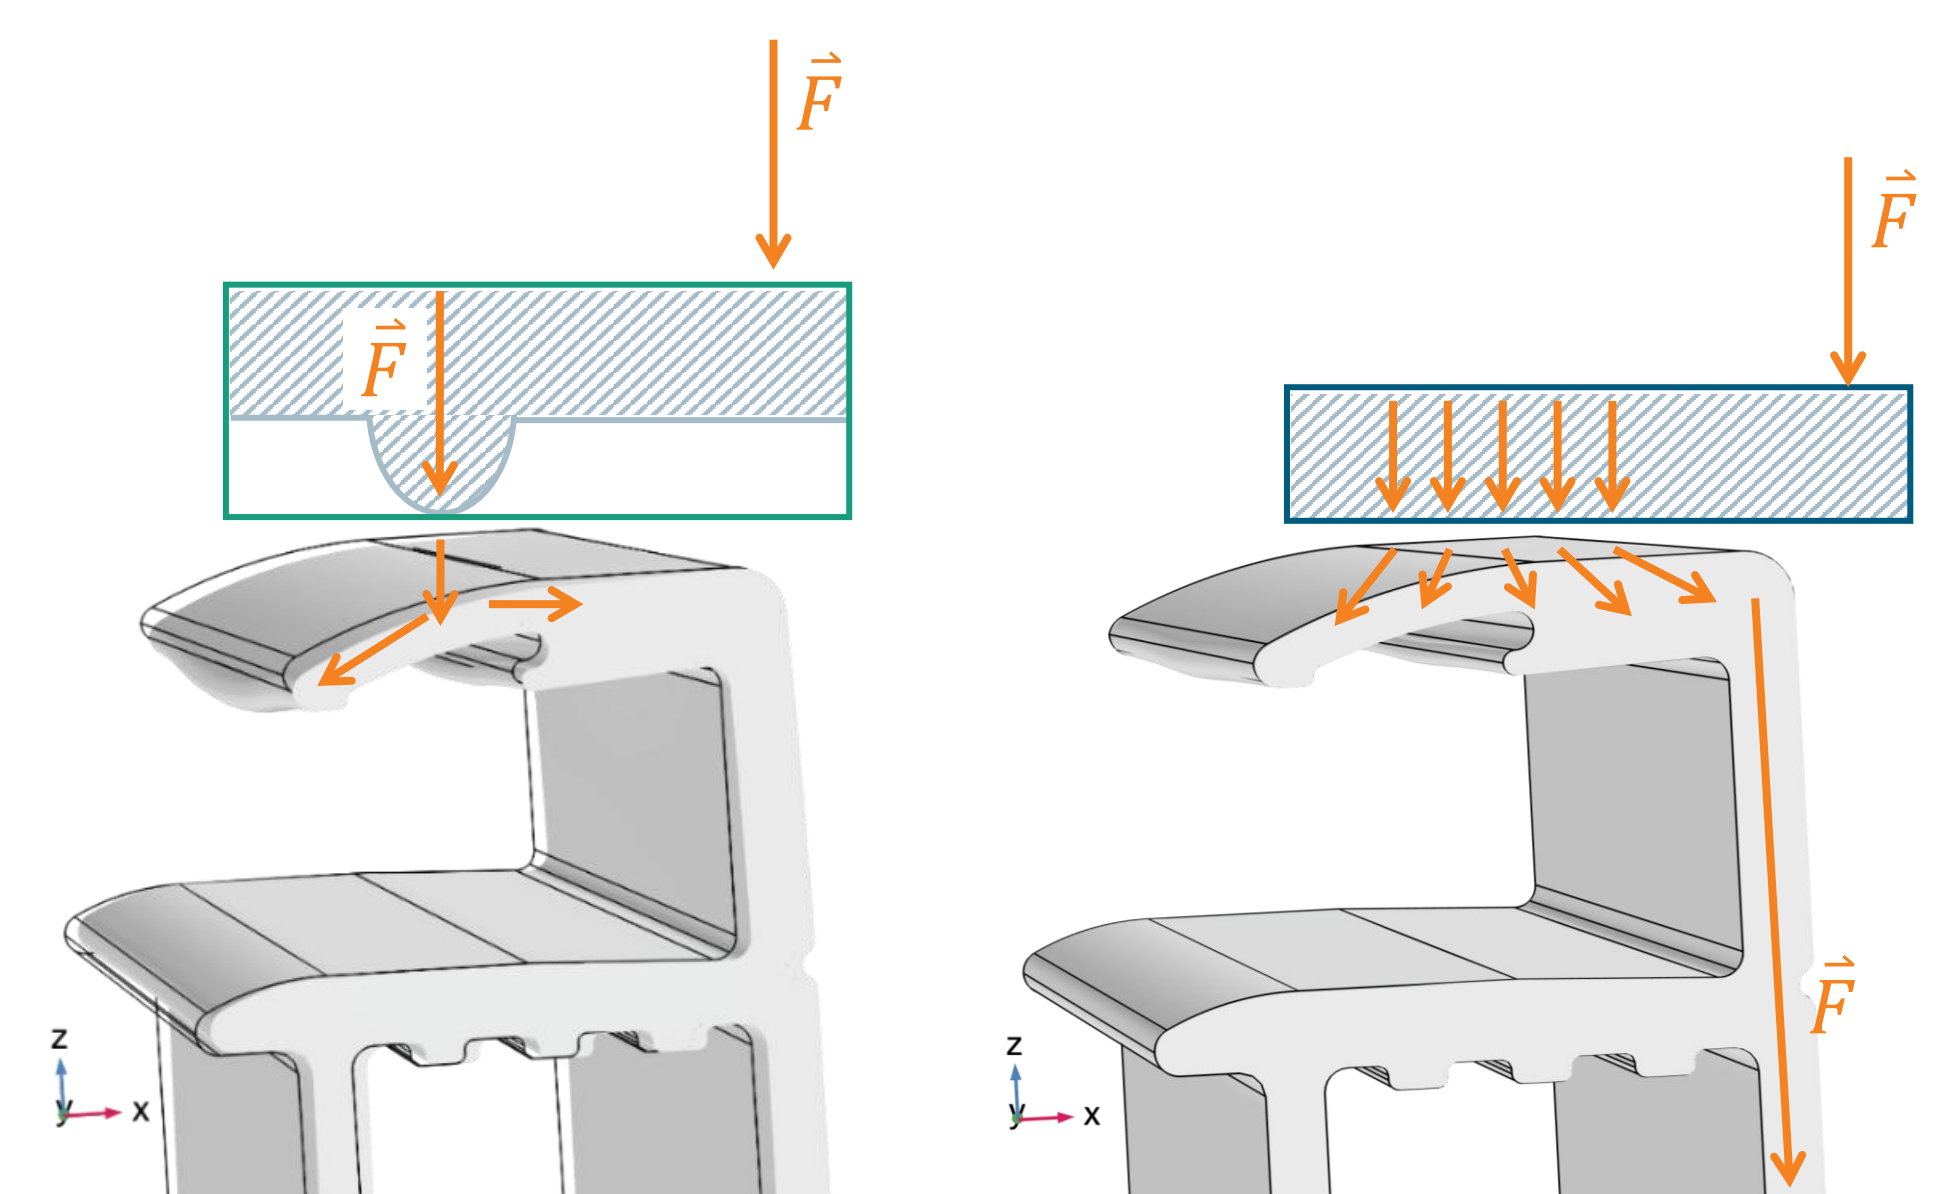
- Using a clamp without a grounding groove distributes force evenly across frame, most of the force is transferred through outer leg of frame
- When using a clamp with a grounding groove, the force to the frame is applied linearly and further inward.  
→ Top of the frame bends due to the lever arm  
→ Frame exerts linear pressure on front glass  
→ High tensile stress at contact region
- **Clamps with a grounding groove results in a higher first principal stress in the glass**

Fig. 4: Deformation of module frame when using a clamp with grounding groove (left) and a clamp without grounding groove (right)
