PV FIRE HAZARD - ANALYSIS AND ASSESSMENT OF FIRE INCIDENTS

ABSTRACT: This paper addresses an investigation of heat damages and fires of PV systems. Information on damage cases was collected by an online-questionnaire, online research, literature research, by questioning technical experts and from an insurance company's files. Some 180 cases of fire and heat damage were found, where PV systems caused fires affecting the PV system or its surroundings. A statistical analysis or these cases is given. Main reasons for fires were component failures and installation errors. Especially in larger systems improper handling of aluminum cables caused several fires. DC-switches were found to be critical and therefore laboratory testing was conducted. This testing of aged DC switches found increased resistance and potential thermal damage. Operating the switches several times reduced the resistance markedly. Inspection of older PV systems showed that bypass-diodes are reliable and pose a low risk for reverse currents into strings. Recommendations to further improve system safety are given.

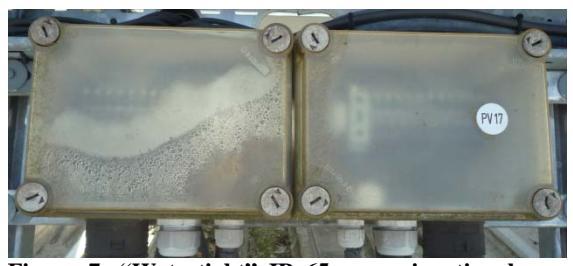
Figure 7: "Watertight" IP 65 array junction boxes after 15 years operation; the left one shows water droplets from condensed vapor.

- cabinets for outdoor use, but without condensation drainage provided → water accumulation → contact corrosion → loss of power (see Figure 7)
- Inverters have been installed at unsuitable places expose to weathering or in an unsuitable way – on or near combustible material. Damages range from defective inverters to burnt down barns.

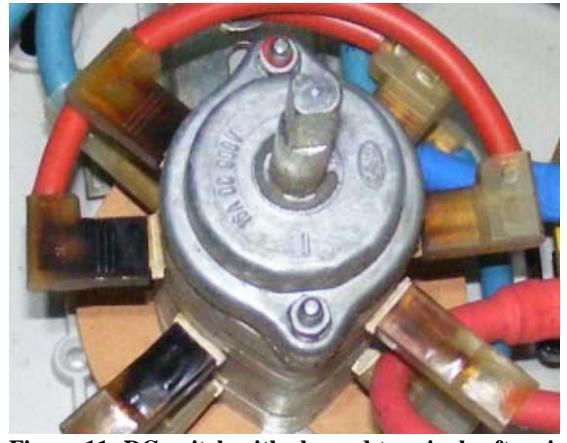
In many more PV systems inspectors found switches with marks of severe overheating (see Figure 11). At the site of a PV fire started by a DC switch the authors found among six "surviving" switches two more switches with charred terminals – out of a total of 15 switches. When we contacted suppliers of these switches, a major retail company mentioned hundreds of product replacements due to charred terminals. One manufacturer told us they were aware of a problem and they had changed the switch design and replaced "FASTON" terminals by screw terminals. Another manufacturer told us they had received little negative feedback from the field. (However, their switches had been built into the mentioned retailer's products.)

Figure 11: DC switch with charred terminals after six years of operation. This damage can be easily detected even by lay persons, if the contacts are visible.

Inspection should be done annually and in combination with maintenance operation of DC switches. Suggested verification interval is four years as for commercial electric installations in Germany.

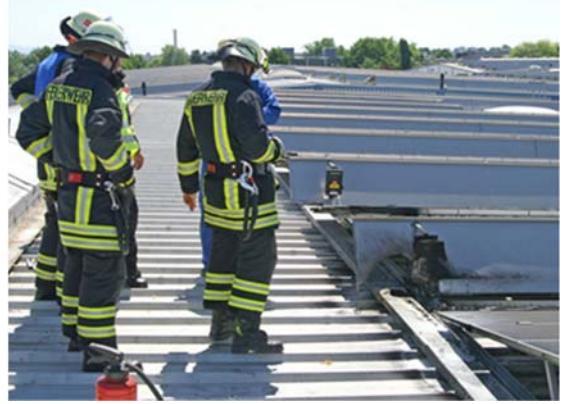
Figure 12 shows the site of a fire which destroyed a generator junction box (j-box). The investigator identified the DC switch as cause of the fire [7]. Actually, the inspector found "lack of maintenance" as final cause of the fire. The switches' manufacturer required annual operation of the switch to clean contacts [8] After the fire all array junction boxes – about 130 boxes - were inspected. In some 10 % of the boxes switches with charred terminals were found.

Figure 12: An array junction box had been destroyed by a fire. The j-boxes were fully exposed to sunlight and weathering. We assume that this exposure has contributed to contact degradation (photo: Freiwillige Feuerwehr (fire department) Bühl).

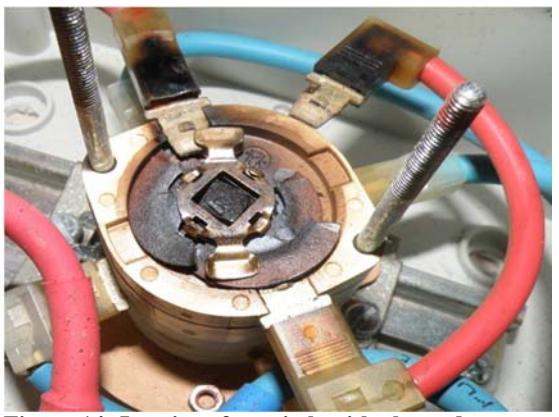
Cause of overheating was first thought to be poor FASTON connectors. Disassembling the switch SW-5 provided clues that indicate that the prime heat source was located within the switch and not at the connectors (see Figure 14). Isolation materials within the switch are completely carbonized. The axis had shrinked and also was carbonized. It was broken and had left a section of the switch "open", another one "closed". Probably, degraded contacts caused internal losses and subsequently internal overheating.

The axis broke exactly when the switch was operated by firemen during the fire. Thus, the safety device failed when it was needed.

Overheating is caused by resistive heating at the switching contacts. The phenomenon of contact degradation is well known among contact manufacturers and attributed to minor movements under thermal cycling ("fretting"). Contact degradation is probably accelerated by high ambient temperatures like those encountered in both reported fire cases - in an uninsulated attic or an unshaded generator junction box on a roof.

Figure 14: Interior of a switch with charred contacts. The switch's axis had been weakened from repeated internal overheating and broke, when fire fighters switched off the system.

- a derating factor taking into account the switch's real ambient temperature to be expected under the prospective mounting situation
- another derating factor taking into account the irradiance condition to be expected, including irradiance enhancements effects [9]. Regular irradiance enhancements effects of up to 1500 W/m² have been reported. This corresponds to doubling internal resistive losses and accelerated contact degradation.
- Maintenance requirements for switches.

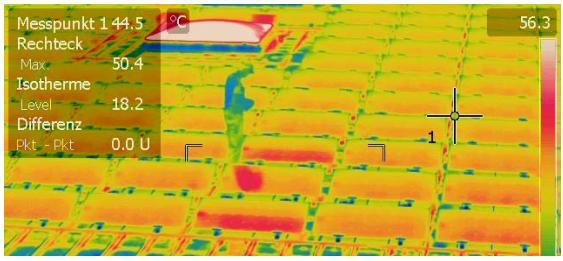
We looked especially for "hot-spots" in Modules and for shorted bypass diodes (BPD) using a thermography camera. The camera was used to identify thermally abnormal modules, where bypass diodes seemed to carry current (see Figure 18).

Figure 18: Infrared view of a module field. Two modules show an abnormality with slightly elevated temperature of a substring, each. The red blot in between is a reflection of the technician's body.

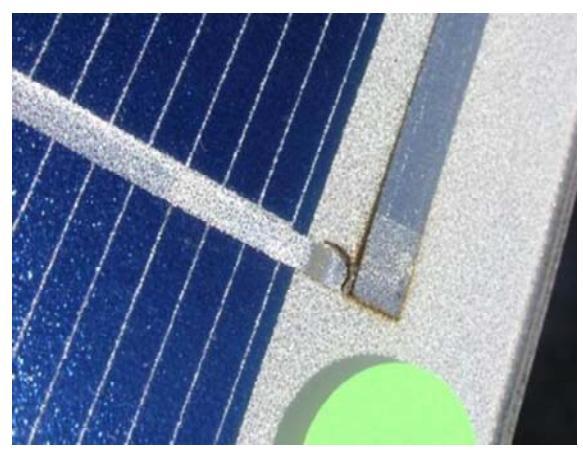
The most frequent fault we found, were "hot-spots" at intra-module soldering between cell interconnect ribbon and module bus bar -6 modules were affected (Figure 19 and Figure 20).

Figure 19: Close-up view of poor soldering. Without thermal imaging camera it is very hard to detect.

To identify long-term degradation and product defects like poor soldering, which eventually could lead to a fire, yield monitoring and regular inspection is recommended. In several cases of module failure from heat damages, output power had decreased over time before the fire.

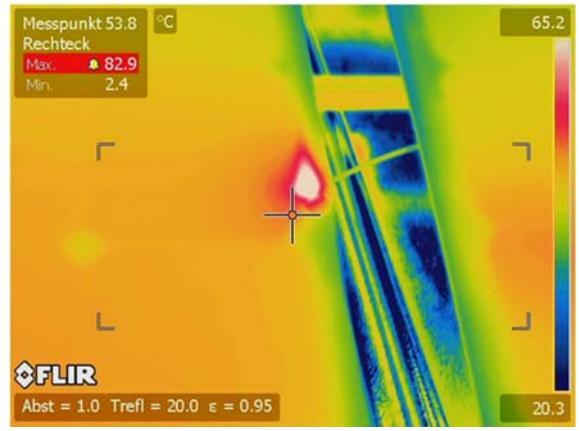
Figure 20: The thermal imaging camera easily detects the faulty solder connection

Inspection of the whole system including all electrical connections with a thermal imaging camera eases detection of critical components significantly.
