PV FIRE HAZARD - ANALYSIS AND ASSESSMENT OF FIRE INCIDENTS

ABSTRACT: This paper addresses an investigation of heat damages and fires of PV systems. Information on damage cases was collected by an online-questionnaire, online research, literature research, by questioning technical experts and from an insurance company's files. Some 180 cases of fire and heat damage were found, where PV systems caused fires affecting the PV system or its surroundings. A statistical analysis or these cases is given. Main reasons for fires were component failures and installation errors. Especially in larger systems improper handling of aluminum cables caused several fires. DC-switches were found to be critical and therefore laboratory testing was conducted. This testing of aged DC switches found increased resistance and potential thermal damage. Operating the switches several times reduced the resistance markedly. Inspection of older PV systems showed that bypass-diodes are reliable and pose a low risk for reverse currents into strings. Recommendations to further improve system safety are given.

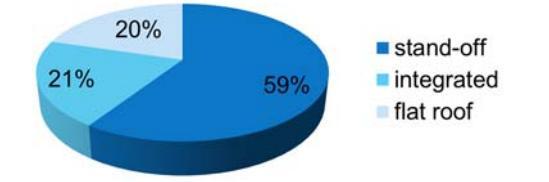
of the whole market. Looking closer at the incidents where building damage had been reported – these are 54 cases – yields the picture in Figure 3. Roof-integrated PV generators account for some 20 % of building damage! Thus, roof-integrated PV systems had a fire risk which is 20 times higher as for regular stand-off mounted PV generators.

Figure 3: For cases of damaged buildings only: distribution of fire reports depending on mounting type

This can easily be explained by the fact that buildings with stand-off system are typically covered by a "hard roof" (i.e. tiles), which shields the building from external fires. For BIPV systems, however, a fire within the PV system is already inside the building.

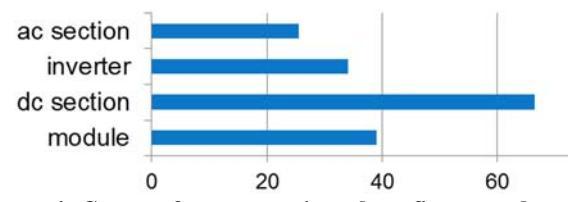
Figure 4: Counts of system section where fire started. AC section includes all components from inverter output terminals to the point of coupling to the grid. DC section includes all components from string connectors at modules to inverter input terminals.

Dominant section in terms of fire risk is the DC section, i.e. string and array cabling and array junction boxes. The main system components, PV modules and inverters, account for roughly half the fire incidents. Surprisingly inverters have been found nearly as often as modules, which are used in far higher numbers. Aside from inverters, the AC section of systems is far more often involved in fires than expected, considering that the components used are regular AC components with a long-term evolution.

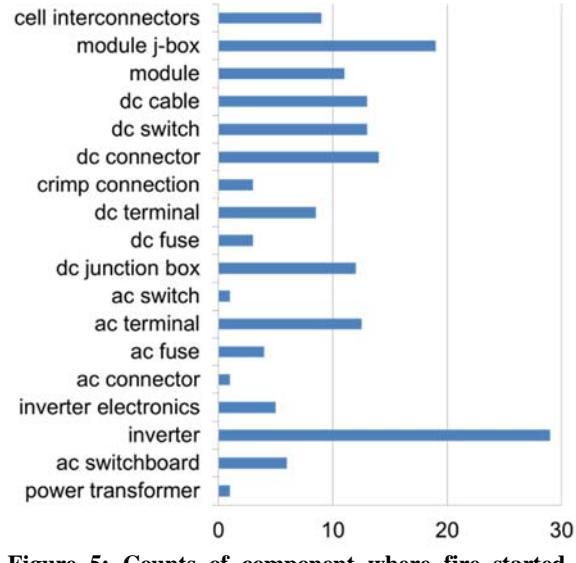
Figure 5: Counts of component where fire started with best available resolution

Other causal components are fairly well distributed. However, it appears that all sorts of connections are sensitive, especially those produced in the field. Furthermore, "dc switch", "dc terminal", "dc junction box" and "ac distribution" often mean use of screw terminals. The authors believe that screw terminals are a potentially weak spot in PV systems and should be replaced by other connection technologies. Tightening screws can be forgotten and good contact quality needs controlled torque according to the terminal manufacturer's specifications. Which installer regularly uses a torque control screwdriver?

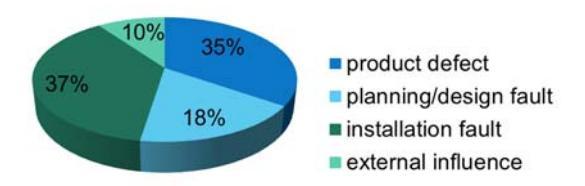
Figure 6: Distribution of identified causes of fire incidents. Installation fault describes poor workmanship.

Installation faults and product defects are the main reasons for damage. They caused roughly 35 % of damages, each.

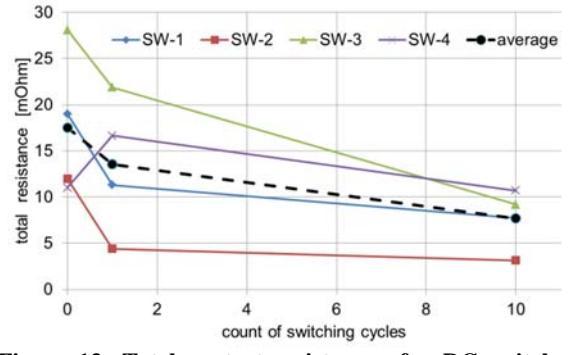
Five of the original switches could be recovered. Switches 1-3 were rated for 25 A, switches 4-5 for 16 A. The switches were tested in the lab for contact resistance and for electric losses from contact resistance. We followed the manufacturer's recommendation and operated the switches for ten cycles. Figure 13 shows the result of the test. Initial total contact resistance varied between about 10 m Ω and 28 m Ω . At rated current this corresponds to about 8 W (25 A switch SW-2), respectively 3 W (16 A switch SW-4) and 17 W (25 A switch SW-3) losses. After "maintenance", losses at rated current ranged between 2 W (SW-2) and 6 W (SW-3).

Figure 13: Total contact resistance of a DC switch with several contact layers as function of switching cycles

Operating the switches ten times reduced contact resistance and losses in average by a factor of about two.

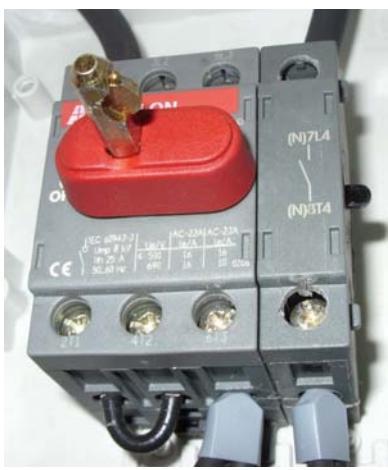
Eight switches of the same type were tested under regular operation in a PV system. They are rated at 16 A and loaded to 8 A at maximum. Switches had been commissioned some ten years before the testing and probably not been operated since, except for Fas2. Switch Fas2 had been open most of the time and been closed about a year ago.

Figure 15: DC switch with four contacts tested in operation at Fraunhofer ISE. Three contacts are connected in series for one pole, one contact switches the second pole.

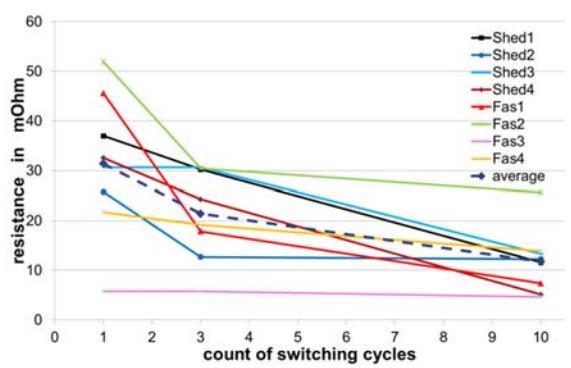
The result of the resistance measurement is shown in Figure 16. The initial contact resistance could not be determined, because the switches are built into locked enclosures. To open the enclosure we had to switch off the systems.

This type of switch, though of a different construction, shows a similar behavior as the former type. Repeated switching reduces contact resistance significantly.

Associated losses at rated current vary from about 13 W (worst case) to 1.3 W (minimum). Marks of overheating were not observed, probably because the switches were operated at maximally half the rated current.

Figure 16: Total contact resistance of eight DC switches as function of switching cycles. Fas2 had been open for years and might therefore have degraded more than the other switches.

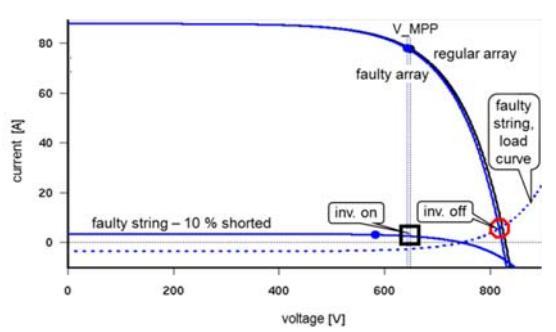
One major fault scenario for fire hazard is reverse current from multiple parallel strings into one string. This may overload modules and string wiring in the faulty string. A recent investigation found that with crystalline silicon technology under regular operation conditions, no reverse current will flow, not during snow cover of one string and not during any other string shading [10]. Shorted strings, e.g. from installation errors or bypass diode failures, however, can cause reverse currents. When strings are electrically shorter by more than 10 % than the rest of the array in parallel, critical reverse currents may occur (Figure 17).

Figure 17: I-V curves at STC of an arbitrary array of 25 strings in parallel (upper/black curve) and of the same array with a faulty string with 2 out of 20 modules shorted (second upper, blue curve). Each string comprises 20 modules. I-V curve of the faulty string is the lower blue curve, and its load curve is dashed blue. While the inverter is running, the faulty string operates at V_mpp and gives a positive contribution to array current. When the inverter is switched off, the operating point of the faulty string is shifted to the intersection of the faulty array's I-V curve with the faulty string's load curve at "inverter off". The faulty string draws about twice its short circuit current. This scenario corresponds to six bypass diodes shorted out of in total 60 bypass diodes in that string.
