# Investigating the Impact of Mounting Clamps and Frame Adhesive Joints on Glass Breakage of PV-Modules

<sup>1</sup>Fraunhofer Institute for Solar Energy Systems ISE, <sup>2</sup>RWE Renewables GmbH, Deutschland

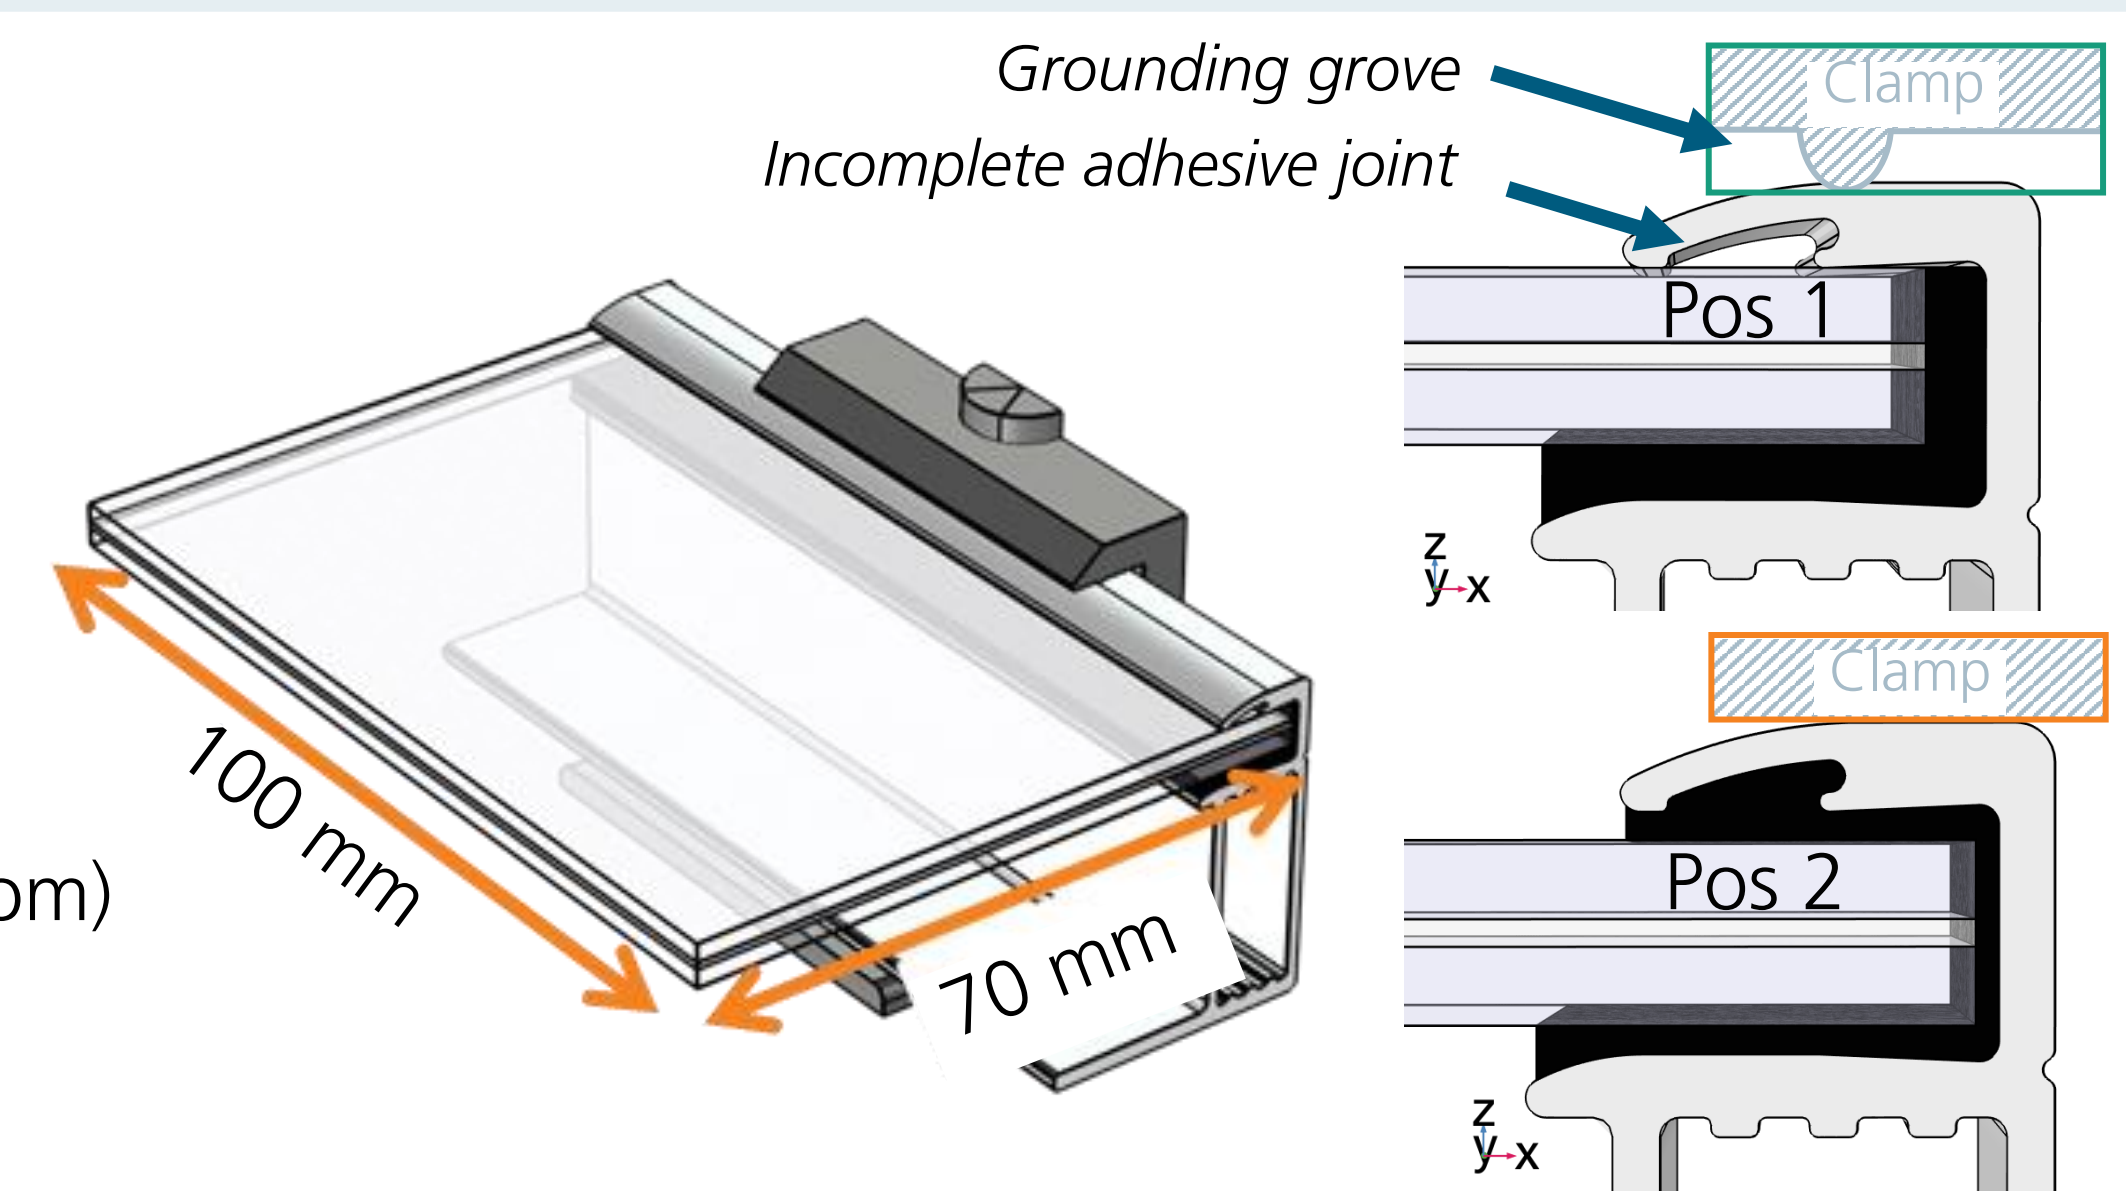
- Simulation of screw tightening up to 20 Nm during clamping process in PV module assembly on a representative section of the module (Fig. 1, left)
- Comparing clamps containing a grounding groove (Fig. 1, top) to clamps without one (Fig. 1, bottom)
- Comparing different positions of the laminate within the frame (Pos 1: incomplete adhesive joint, Pos 2: fully formed adhesive joint)
- Analyzing first principal stress in the glass, caused by the clamping process

Fig. 1: Simulated representative section, containing the laminate, frame, adhesive, mounting clamp and the screw
